Axis Building en Plaza Colón

Madrid, Spain / 2018

Owner
Client
Scope
Architect

CBRE Global Investors
Foster + Partners
detailed design and construction support
Foster + Partners

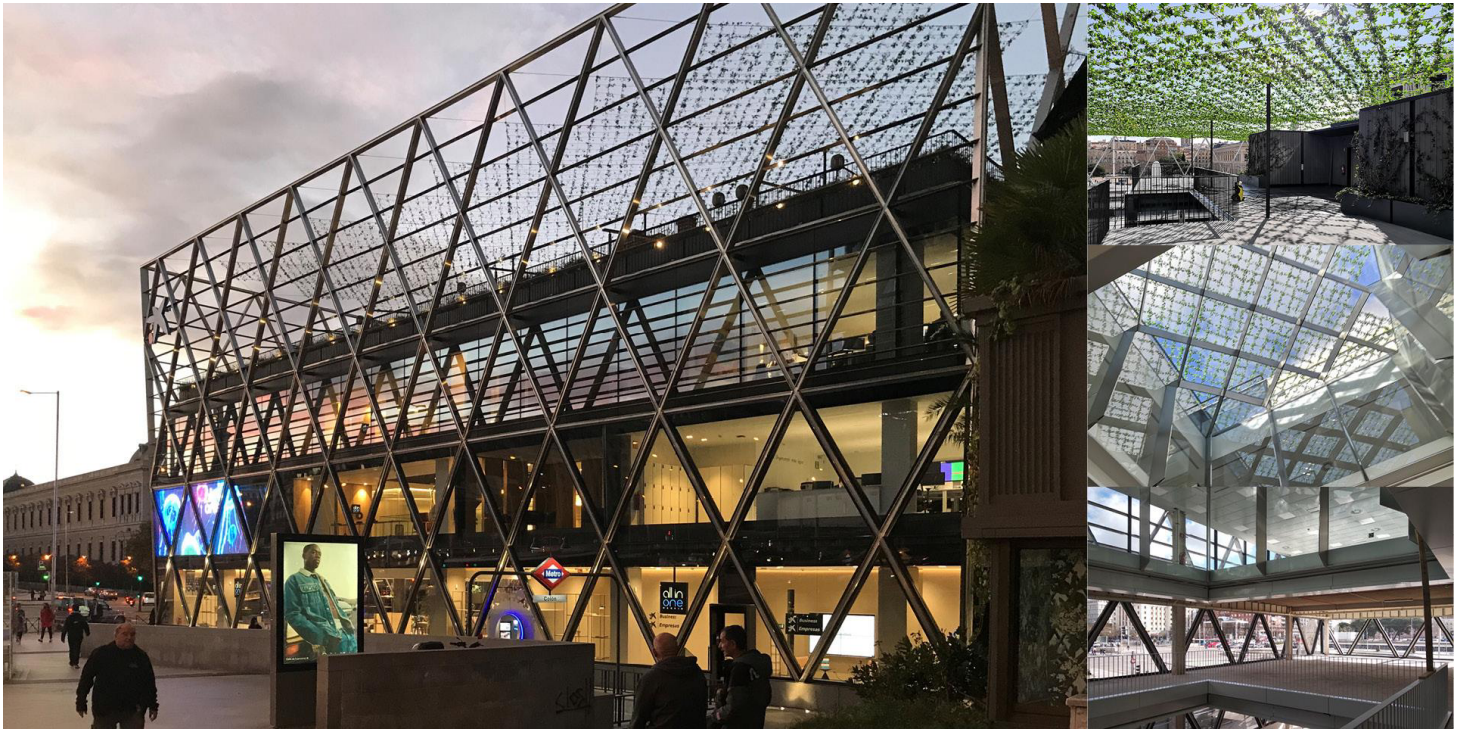
Refurbishment of the building located at Colón 1 Square. The main structure is adapted to new commercial use in three of the levels, while the rest will be offices. The project includes the opening of a large central atrium, the removal of the existing façade and the execution of a new one as a diagrid and a catenary structure that will create a garden on the roof.

FHECOR participates directly in this interesting project, carrying out an assessment and refurbishment of the existing structure to update it to the new requirements, and working at the new and distinctive diagrid of the façade as well as at one structure of catenaries that will allow creating a garden at the roof with a view of Colón Square.
